Putting children first: Tackling lead in water at child care facilities

Authors

Lindsay A. McCormick
Chemicals and Health Project Manager

Sam C. Lovell
Health Project Specialist

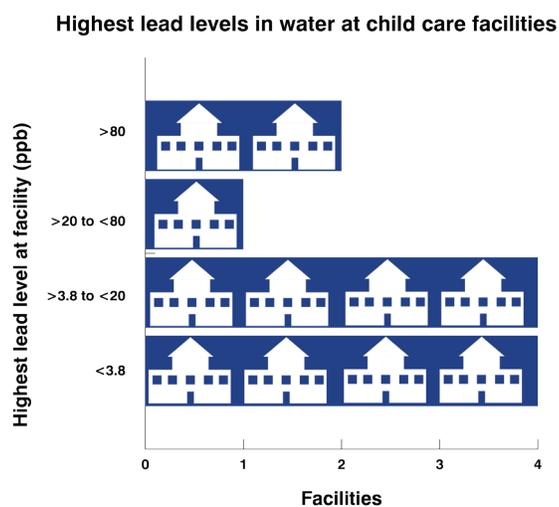
Graphic illustrates the highest lead level detected at each of 11 child care facilities, excluding samples from non-drinking sources such as utility sinks and hose bibs. Our pilot used a health-based action level of 3.8 ppb to trigger remediation.

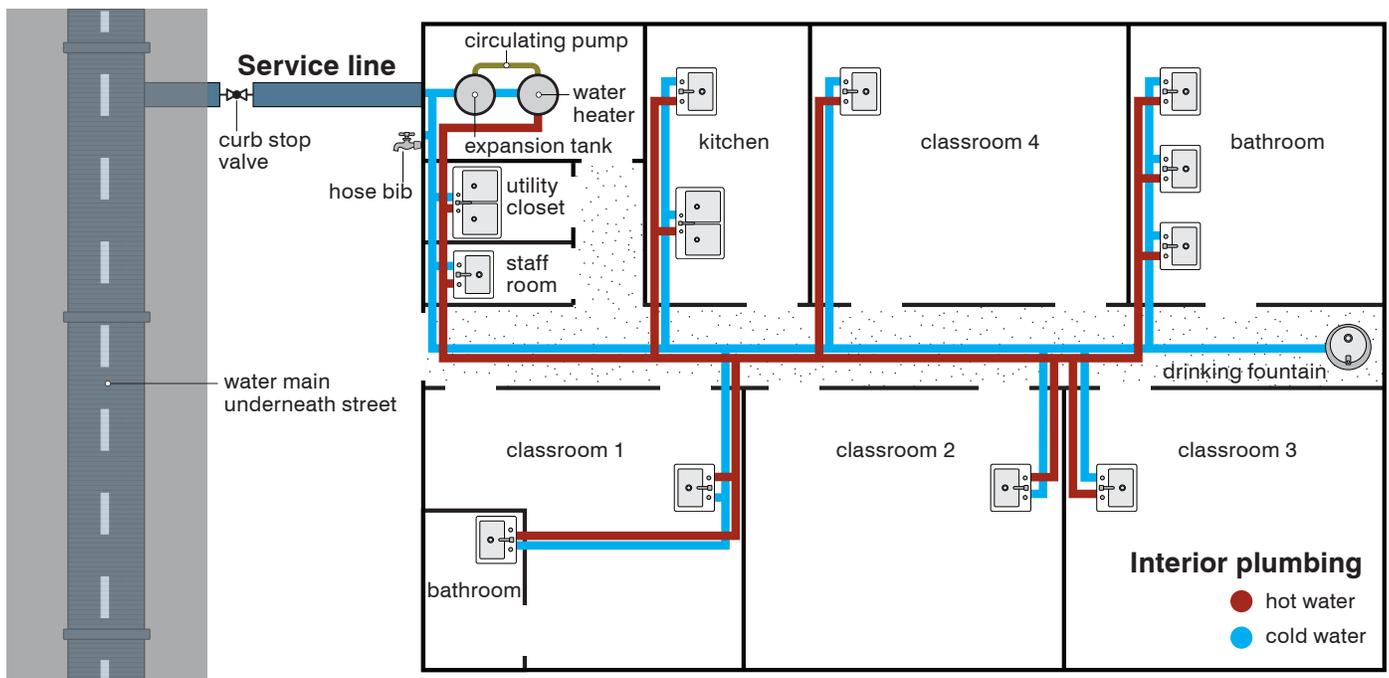
FIGURE 2

Water distribution system at typical center-based child care facility

The layout of the water distribution system in a typical center-based child care facility is illustrated in Figure 2. Water enters the building through the service line and is connected through interior plumbing. The service line usually enters the building near the water heater, which produces hot water for the facility (red). Large centers may have an expansion tank connected to the water heater, which manages pressure changes due to temperature fluctuations. Classrooms often have sinks and bathrooms, and most center-based facilities also have at least one kitchen, staff room, and utility closet.

Based on EPA's 3Ts guidance, our partners collected 250 mL water samples after allowing the water to sit in the pipes overnight (8-18 hour stagnation) at all water fixtures, including kitchen, classroom, bathroom, staff room, and utility closet sinks; drinking water fountains; and outdoor hose bibs (see Figure 2 above).

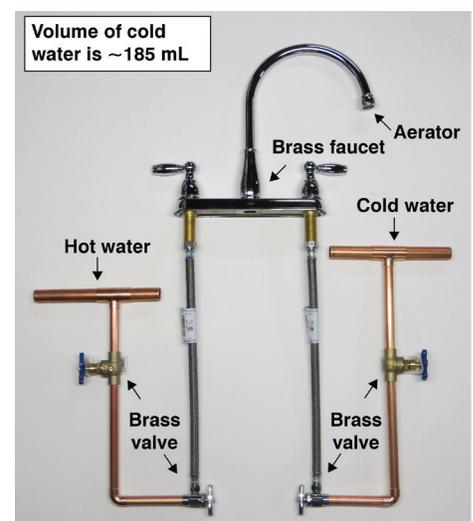
FIGURE 3

A typical brass faucet and associated plumbing is shown in Figure 3. In this example, the cold water volume—including the faucet through the plumbing shown—is about 185 mL. Therefore, a

Typical fixture and associated plumbing

250 mL sample (as recommended by EPA's 3Ts guidance) would include the faucet and associated plumbing beyond that pictured here.

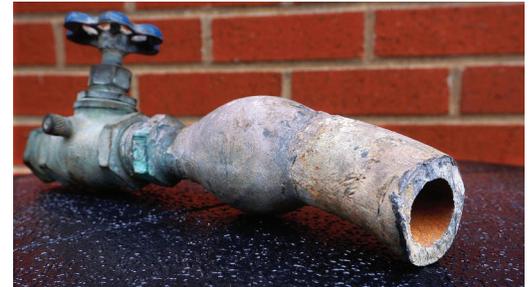
Image of a lead service line. Source: Associated Press.

At each facility, our local partner(s) first investigated whether there was an LSL by reviewing historical records, contacting the local water utility, and conducting a visual inspection. LSLs can unpredictably release particulate lead that either passes into the water immediately or gets caught in the aerators, connections, or pipe scales to be released later. As recommended by the [Lead Service Line Replacement Collaborative](#), the best long-term solution to addressing LSLs is to remove them. Therefore, if an LSL was found, without regard to lead levels detected in the water, we worked with partners to arrange for its removal and to ensure appropriate flushing was completed before conducting regular fixture sampling, described below.

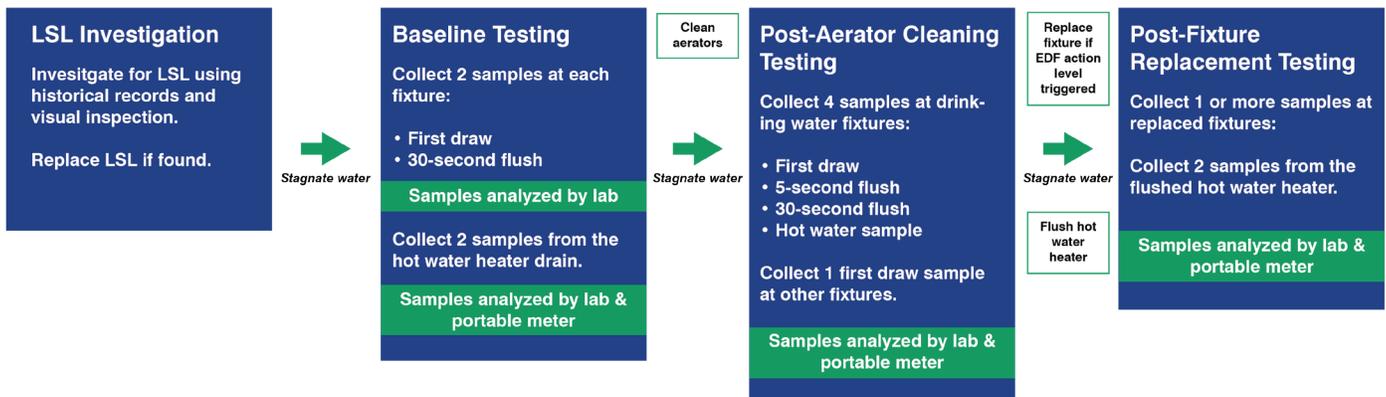
FIGURE 4
Lead in water testing protocol for EDF's pilot

Our general sampling and remediation protocol is outlined in Figure 4. Our local partners conducted all lead sampling and coordinated remediation methods with the facilities. We adapted our protocol to local circumstances.

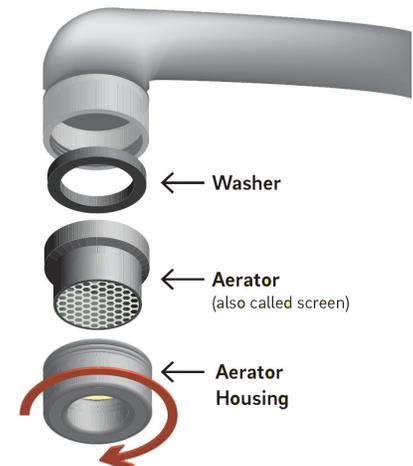
FIGURE 5
Diagram of faucet aerator

Where present, we cleaned the aerator—a screen often found at the end of a faucet—between the first and second day of sampling to remove lead particulates potentially caught in the screen. We removed the screens and washed them thoroughly in the tap water. See Figure 5.

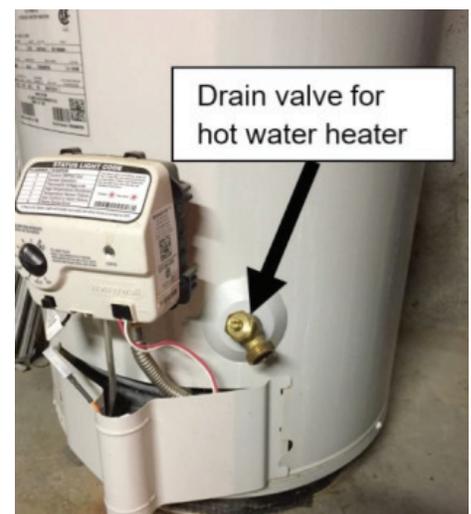
FIGURE 6
Water heater with drain valve

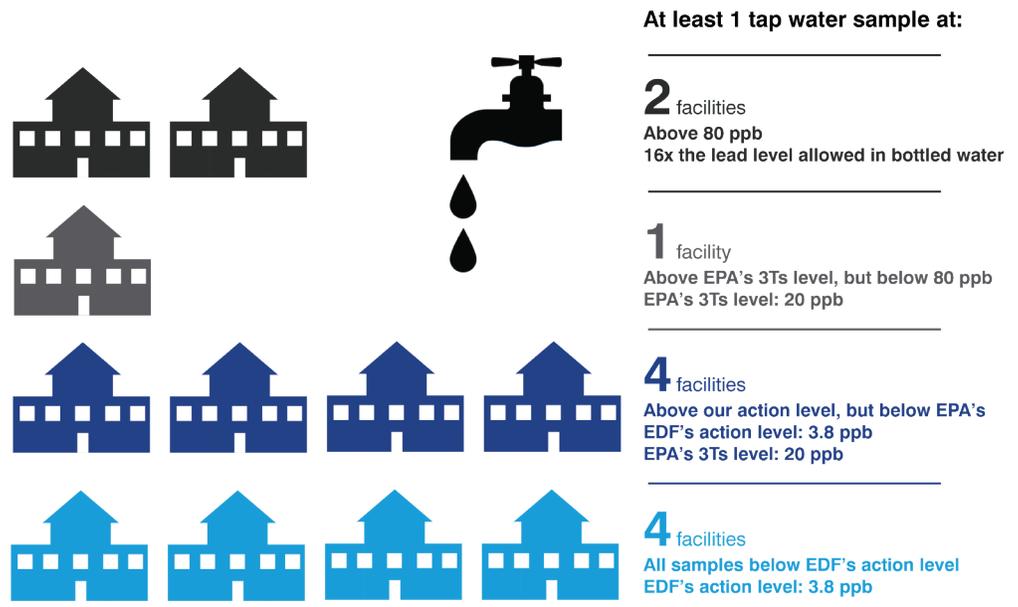
FIGURE 7

Highest lead levels in drinking water at 11 child care facilities

Results of water testing (excluding samples from utility sinks and hose bibs) at 11 child care facilities: two facilities had at least one tap water sample above 80 ppb level of lead; one facility had at least one sample above EPA's 3Ts action level of 20 ppb, but below 80 ppb; four facilities had at least one sample above our health-based action level of 3.8 ppb, but below 20 ppb; and 4 facilities had all samples below EDF's action level of 3.8 ppb.

We found that four of the 11 child care facilities had no drinking water fixtures exceeding our action level of 3.8 ppb while seven had at least one drinking water fixture that triggered our action level on either day one or two of sampling—and therefore could be source of lead exposure to children in the facility. Of these, three were above the EPA 3Ts action level of 20 ppb with two facilities, in Chicago and Cincinnati, with highs greater than 80 ppb. The highest drinking water samples at the remaining four facilities were between our action level and EPA's current 3Ts action level. See Figure 7.

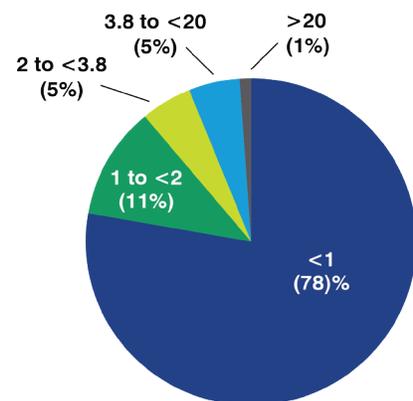
FIGURE 8

Lead levels in baseline first draw samples (ppb)

Figure 8 provides the results for the first draw baseline samples—samples modeled after EPA's 3Ts guidance—for the 291 fixtures we tested.³ More than three out of four of the baseline first draw samples had levels below 1 ppb. Seventeen of 291 (6%) exceeded our action level of 3.8 ppb and only two (1%) exceeded EPA's 3Ts trigger of 20 ppb. On average, lead levels were higher on the second day of testing, following aerator cleaning (see page 21).

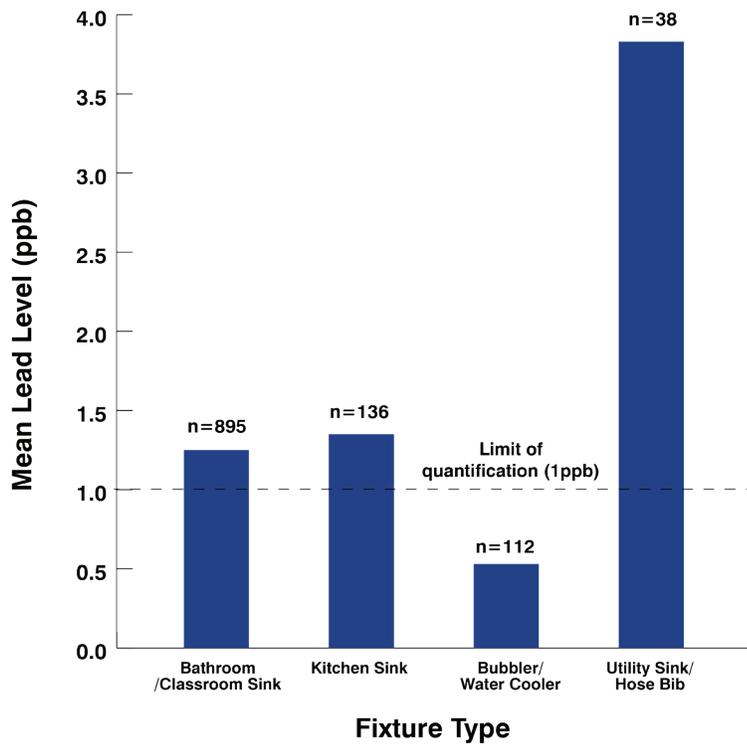
FIGURE 9
Mean lead level by fixture type

This chart illustrates the mean lead levels by fixture type for all samples (excluding those collected before LSL replacement or after fixture replacement as well as hot water samples). When levels were below the limit of quantification (1 ppb), we used 0.5 ppb.

Samples also varied by fixture type. Figure 9 illustrates the mean lead level by fixture type. Drinking water fountains (bubblers and water coolers) had the lowest lead levels, with nearly all non-detectable lead levels (non-detects reported as 0.5 ppb in Figure 9). Kitchen sinks had an average lead level of 1.4 ppb (range <1-27 ppb). Though we had a limited sample size, non-drinking water faucets, like utility sinks and outside hose bibs, had the highest lead levels (average 3.8 ppb, range <1-35.6 ppb).

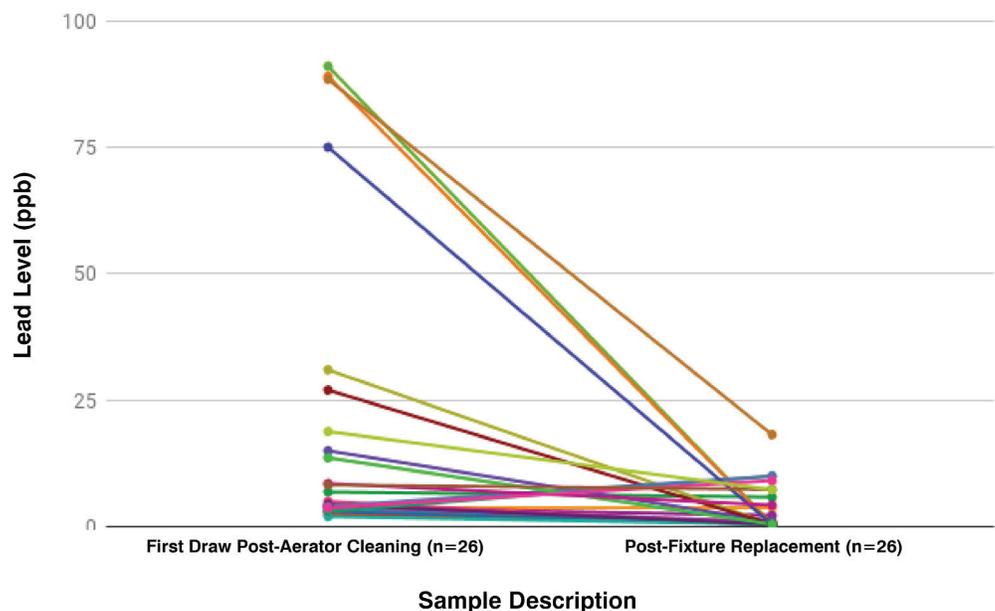
FIGURE 10

Lead levels before and after fixture replacement (all samples)

This chart illustrates lead levels at fixtures for first draw post-aerator cleaning and post-fixture replacement. Lines connect data for a single fixture.

Figure 10 illustrates lead levels before and after fixture replacement. We found that fixture replacement was effective when initial lead levels were high. When levels post-aerator cleaning were >5 ppb, fixture replacement led to an average reduction of 19.9 ppb (± 6.3 ppb) in lead levels.

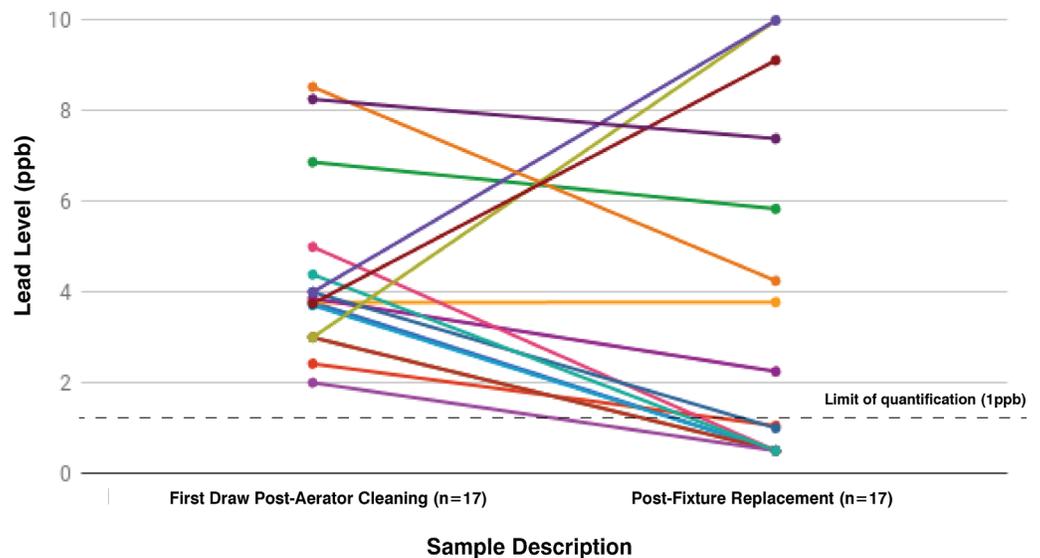
FIGURE 11
Lead level before and after fixture replacement when baseline samples ≤ 10 ppb

This chart illustrates lead levels at fixtures for first draw post-aerator cleaning and post-fixture replacement when the initial sample was 10 ppb or lower. Lines connect data for a single fixture. The limit of quantification for ICP-MS (1 ppb) is indicated with a dashed line; samples below the limit of quantification are plotted at 0.5 ppb.

However, where lead levels were initially close to our action level, replacement was not consistently effective (see Figure 11). In fact, when levels post-aerator cleaning were <5 ppb, fixture replacement on average resulted in a 2.0 ppb (± 1.0 ppb) increase in lead levels. While most initial follow-up testing results were under our action level (71%), a handful of fixtures (29%) tested above our action level following replacement. At two facilities, we conducted follow-up testing within 1-2 days after replacement. Three of these fixtures temporarily had higher lead levels following fixture replacement than prior to replacement, but decreased over time (data on decrease over time not shown).

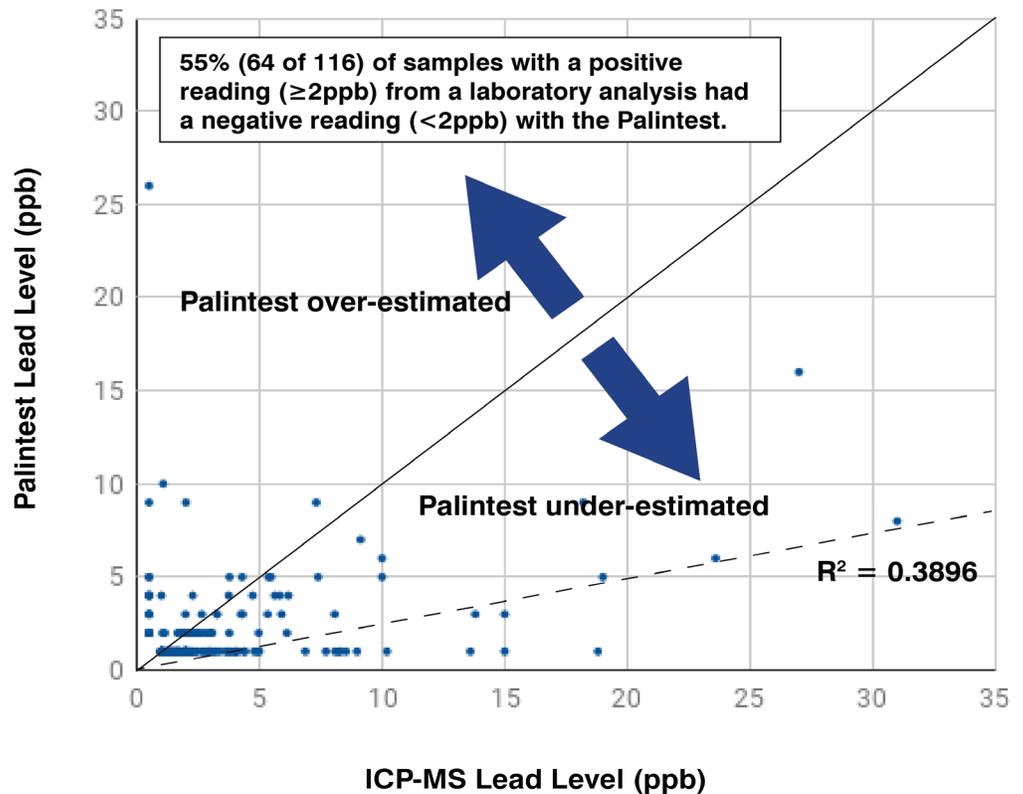
FIGURE 12
Comparing Palintest and ICP-MS lab results

This chart compares sample results from the Palintest meter to the ICP-MS laboratory analysis. When the reading was below the limit of quantification (2 ppb for Palintest and 1 ppb for ICP-MS), we plotted the value at half the limit of quantification. The dotted line represents the observed correlation between the ICP-MS and Palintest measurements, while the solid line represents what the trendline would be if the two tests were perfectly correlated.

Palintest portable lead meter tended to underestimate lead in water levels compared to the laboratory analysis (Figure 12), likely because the Palintest protocol does not include a full acid digestion to solubilize any particulate lead. Of 116 samples, 55% (64) with a positive reading (≥ 2 ppb) from laboratory analysis had a negative reading (< 2 ppb) with the Palintest. In 18 instances (11% of the samples), the Palintest had a positive reading (≥ 2 ppb) while the laboratory results were below the limit of quantification (< 1 ppb); however, 14 of these samples came from the same meter and we suspect there may have been a technical issue resulting in false readings.

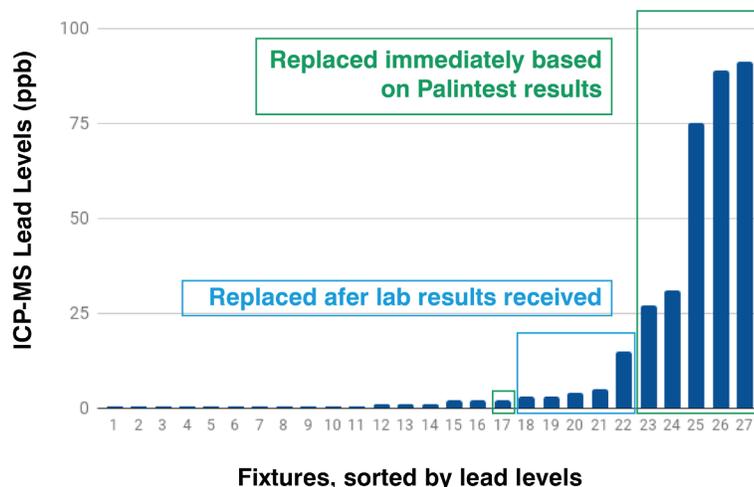
FIGURE 13

ICP-MS results for 27 drinking water fixtures

We received the laboratory results 18 days after fixture replacement. The lab results demonstrated that 10 drinking water fixtures had lead levels above the action level we used in Chicago (>2 ppb). The five with the highest ICP-MS levels (27-91 ppb) had been flagged by the Palintest meter and had already been replaced (Figure 13). The sixth fixture we had replaced based on the Palintest meter (#17 on Figure 13), had a lead level of just 2 ppb based on the ICP-MS analysis. We would not have replaced this fixture based on the ICP-MS results.

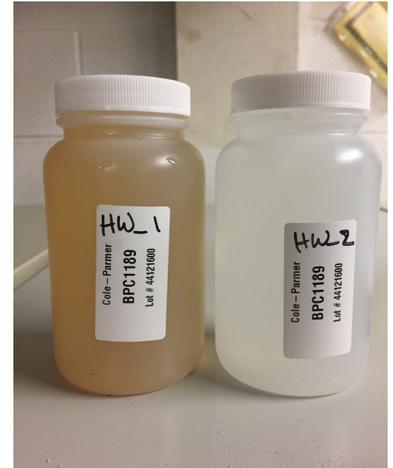
Water samples collected directly from water heater drain. Initial draw pictured on the left.

We found alarmingly high lead levels from the samples collected from the drains of hot water heaters, which we think likely accumulated over time from upstream sources of lead. Half (seven of 14) of water heater tanks tested in child care facilities had levels over 50 ppb, with one as high as 2,680 ppb. The initial samples from the water heater often were discolored—some even like a sludge.

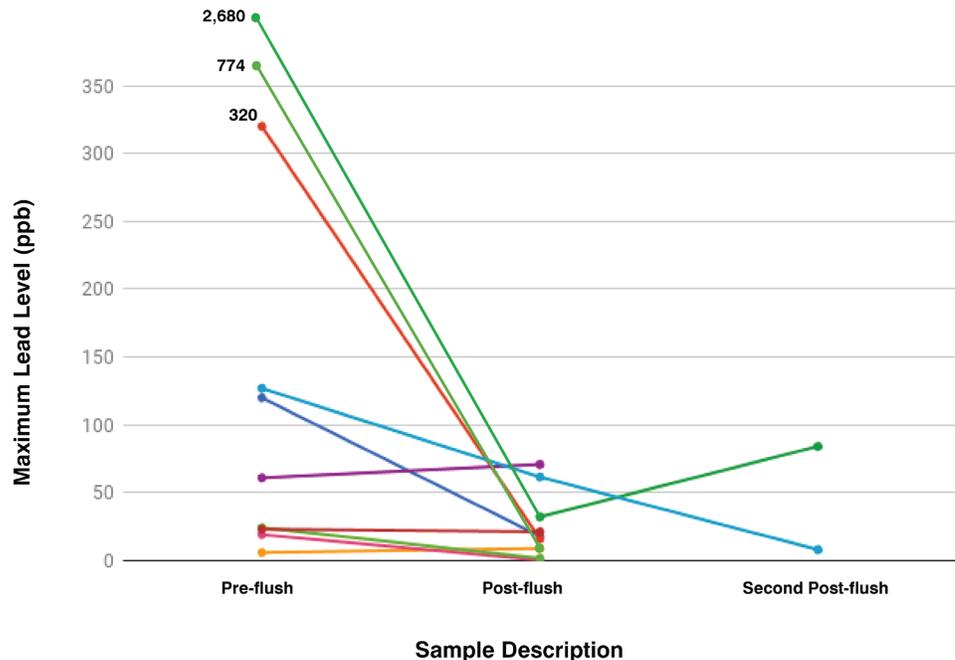
FIGURE 14

Lead results for 10 water heaters: Before and after flushing

Measured lead levels in 250 mL of water collected from 10 hot water heaters in 9 child care facilities. Pictured: Highest lead level detected during each sampling phase—the initial sampling (pre-flush), following a full flush of the water heater (post-flush), and following a second flush of the water heater (second post-flush). Lines connect data for a single water heater.

Our partners performed sustained flushes through the drain on 10 water heater tanks to remove accumulated sludge and particulate (Figure 14). The flushing helped significantly in all but one case. Among water heaters where initial samples tested above 50 ppb, flushing dropped the lead levels on average from 456 ppb to 20 ppb. When initial water heater samples tested below 50 ppb, the drop was less evident (from 17 ppb pre-flush to 13 ppb post-flush, on average). In two cases, our partners performed second flushes in an attempt to further reduce the lead levels (with mixed results). Flushing the water heater can be challenging, however, if there is not a floor drain nearby. Some facilities may need a plumber’s assistance to perform a sustained flush of the water heater.
